Manhole Inspection Summary

Manhole # S41W1_005MH

Insp Date: **12/5/07 1:09 PM**

Location Address: **6th & Annabel**

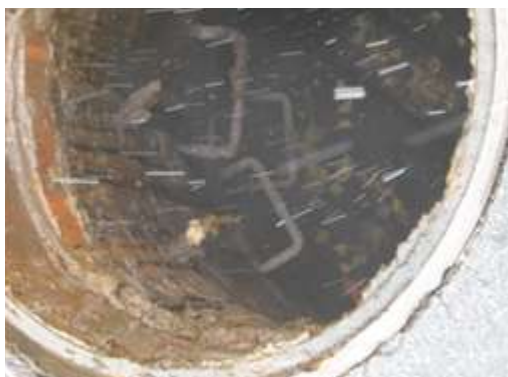
Steps

Count: **3** Missing: **1** ☒ **Corroded**

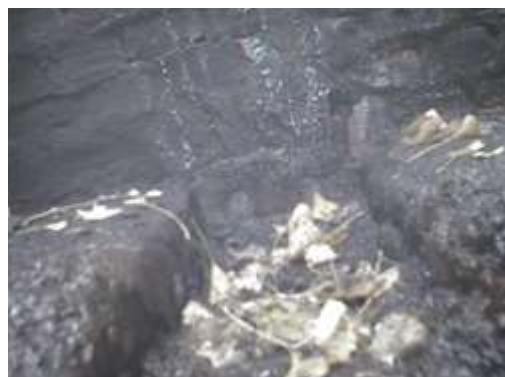
No pipe at 6 o'clock

Line shown at 6 o'clock in GIS has been abandoned. No line enters manhole from that direction.

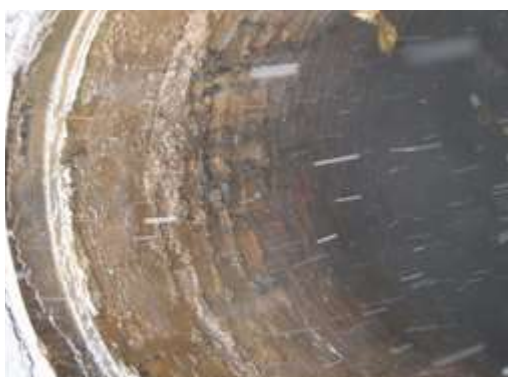
Defect 2

Condition: ☐ Sound ☒ **Cracked** ☐ Root Intrusion ☐ Loose Brick ☐ Deteriorated

Infiltration: ☐ None ☒ **Joint** ☒ **Cracks** ☒ **Mortar** ☐ Roots ☒ **Wall**

Infiltration

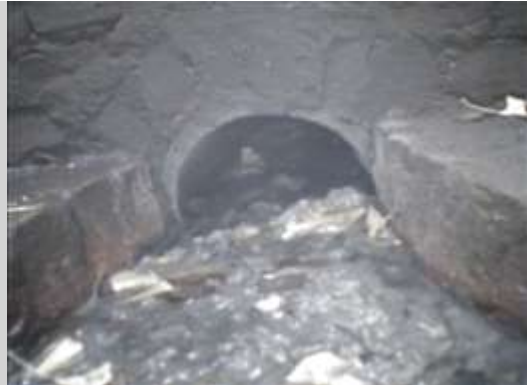
12 O'Clock Outflow

Pipe Height: **7.2** (in.) Rod and Bar (Angled)
Pipe Material: **Clay** ☐ Pipe Lined
Invert Depth: **8.08** (ft.) Flow Characteristics: **Slow**
Deposits: ☐ None ☒ **Mud** ☒ **Grassy** ☐ Debris ☐ Grease
Silt Depth: **1** (in.) Deposits Extent: **Medium**
Infiltration: **None** Pipe Seal Cond: **Sound**

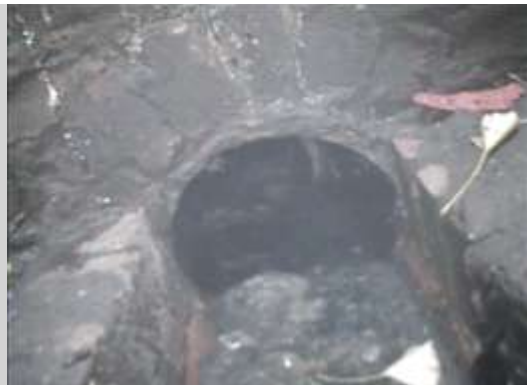
3 O'Clock Inflow

Pipe Height: **8.4** (in.) Rod and Bar (Angled)
Pipe Material: **Clay** ☐ Pipe Lined
Invert Depth: **8.06** (ft.) Flow Characteristics: **Slow**
Deposits: ☐ None ☒ **Mud** ☒ **Grassy** ☐ Debris ☐ Grease
Silt Depth: **1** (in.) Deposits Extent: **Medium**
Infiltration: **None** Pipe Seal Cond: **Cracked**

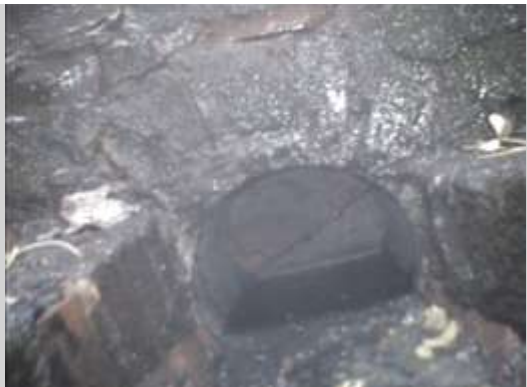
9 O'Clock Inflow

Pipe Height: **8.4** (in.) Rod and Bar (Angled)
Pipe Material: **Clay** ☐ Pipe Lined
Invert Depth: **7.97** (ft.) Flow Characteristics: **Slow**
Deposits: ☐ None ☒ **Mud** ☒ **Sludge** ☐ Debris ☐ Grease
Silt Depth: **0.5** (in.) Deposits Extent: **Medium**
Infiltration: **None** Pipe Seal Cond: **Sound**
